SERVICE BULLETIN: # SB-063

AFFECTED PRODUCTS: CH77 Ranabot , CH7 Kompress Charlie , CH7 Kompress , CH7 Angel 912 , CH

SUBJECT: GOVERNOR CARD

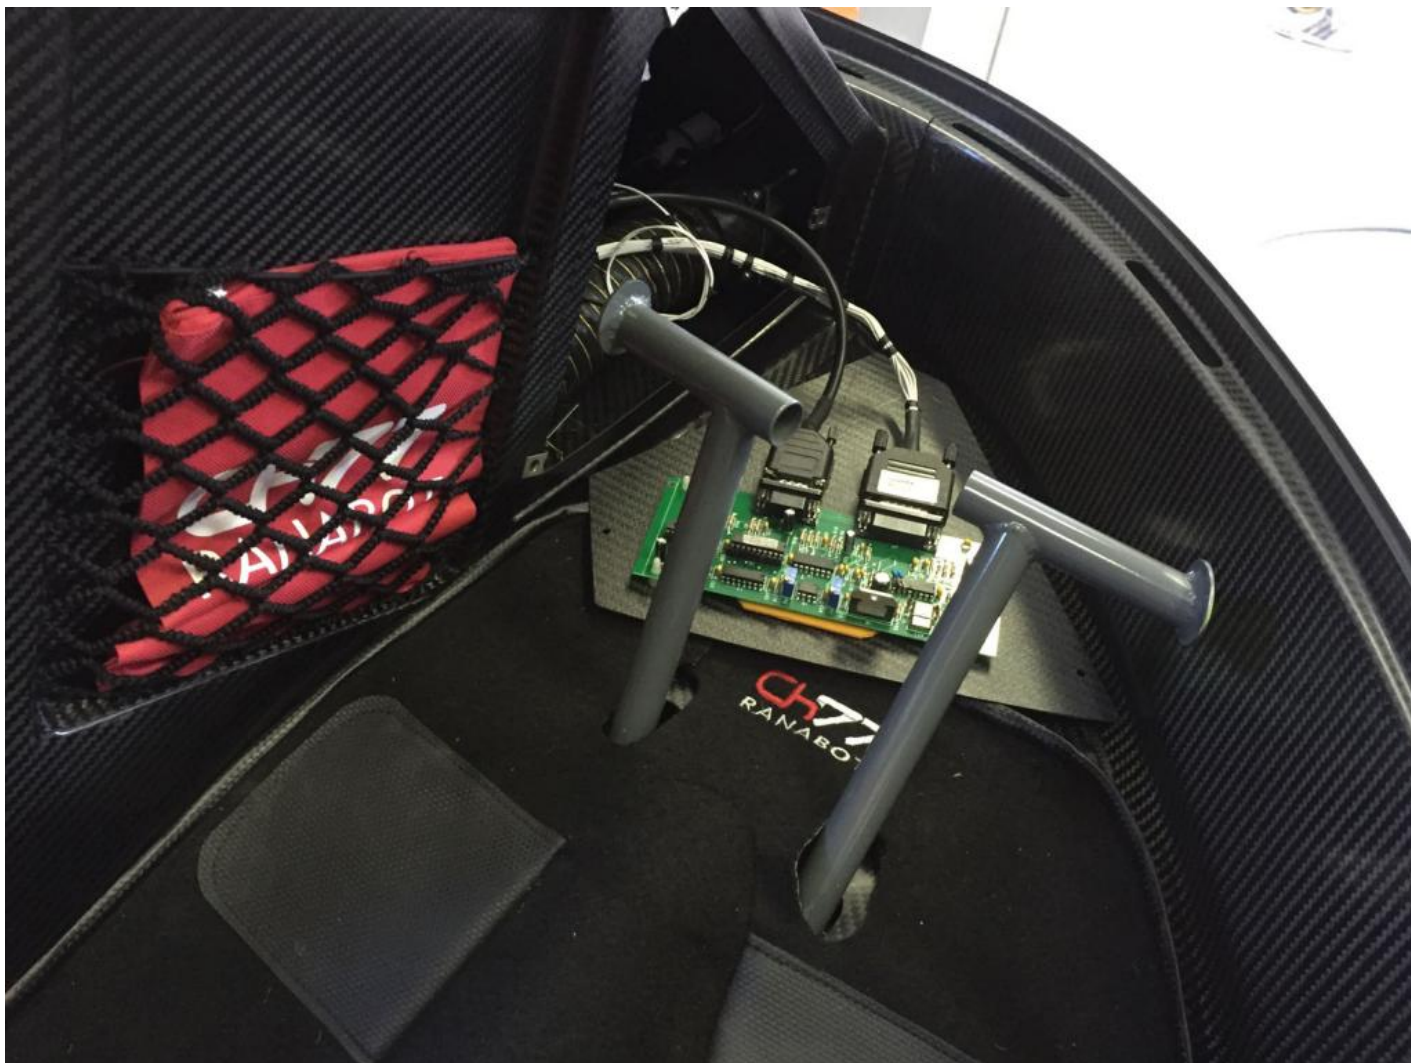
1) CH 77 RANABOT

CH77 RANABOT GOVERNOR CARD LOCATION

Remove from the Helicopter the governor card

(1)send the governor card to CH7 Helisport HELICOPTERS or authorized service center.

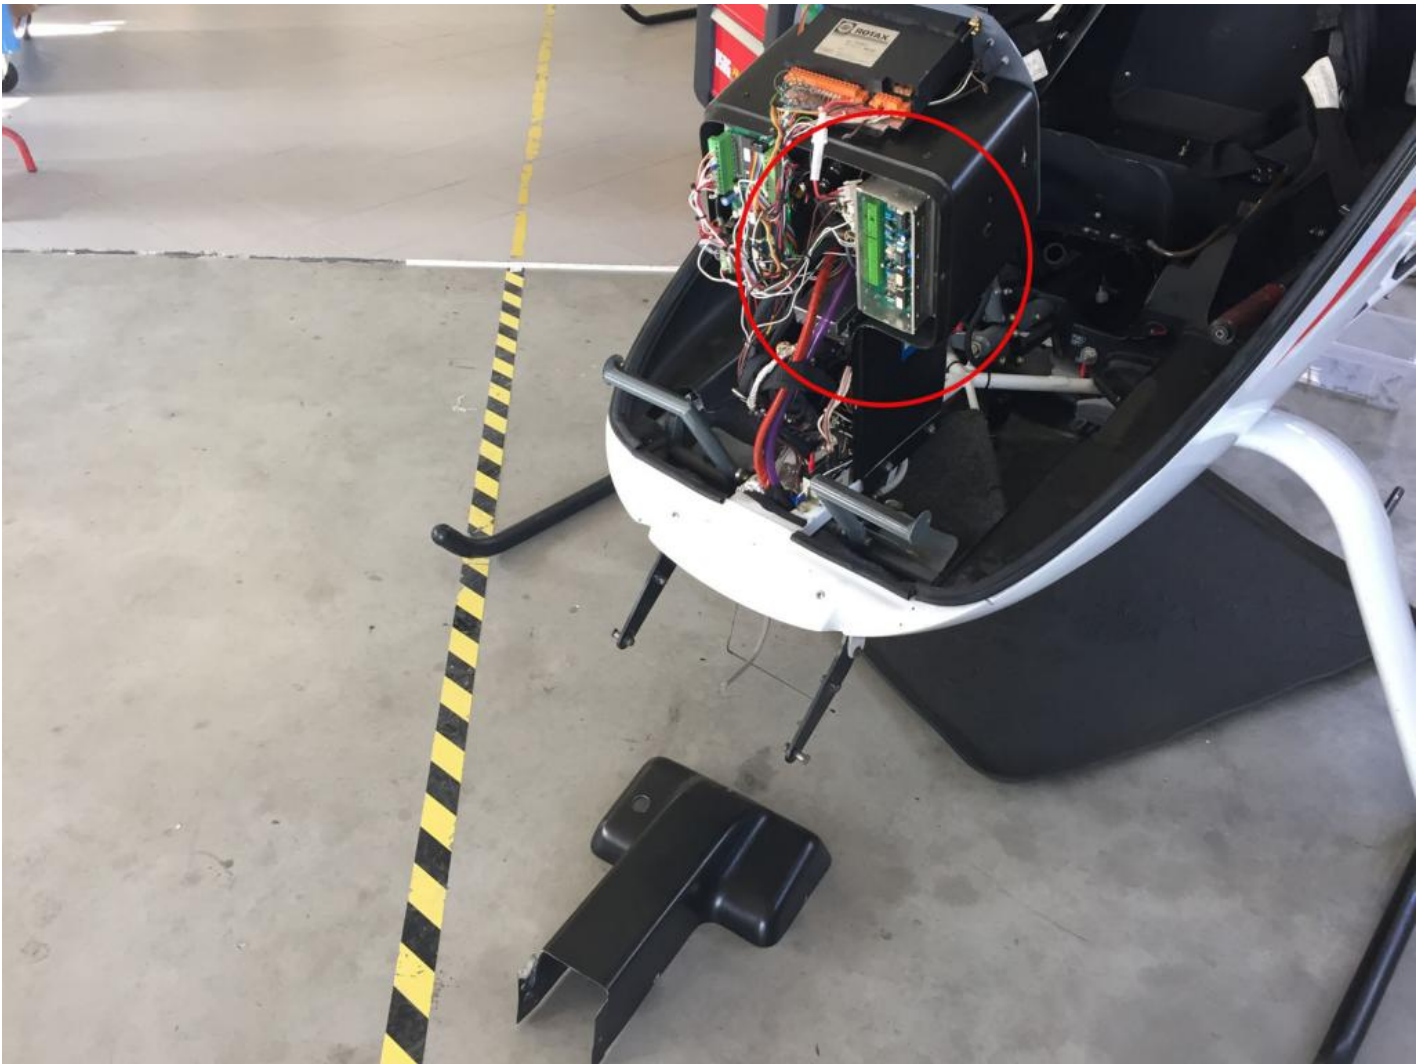
2) CH7 KOMPRESS

CH7 KOMPRESS GOVERNOR CARD LOCATION

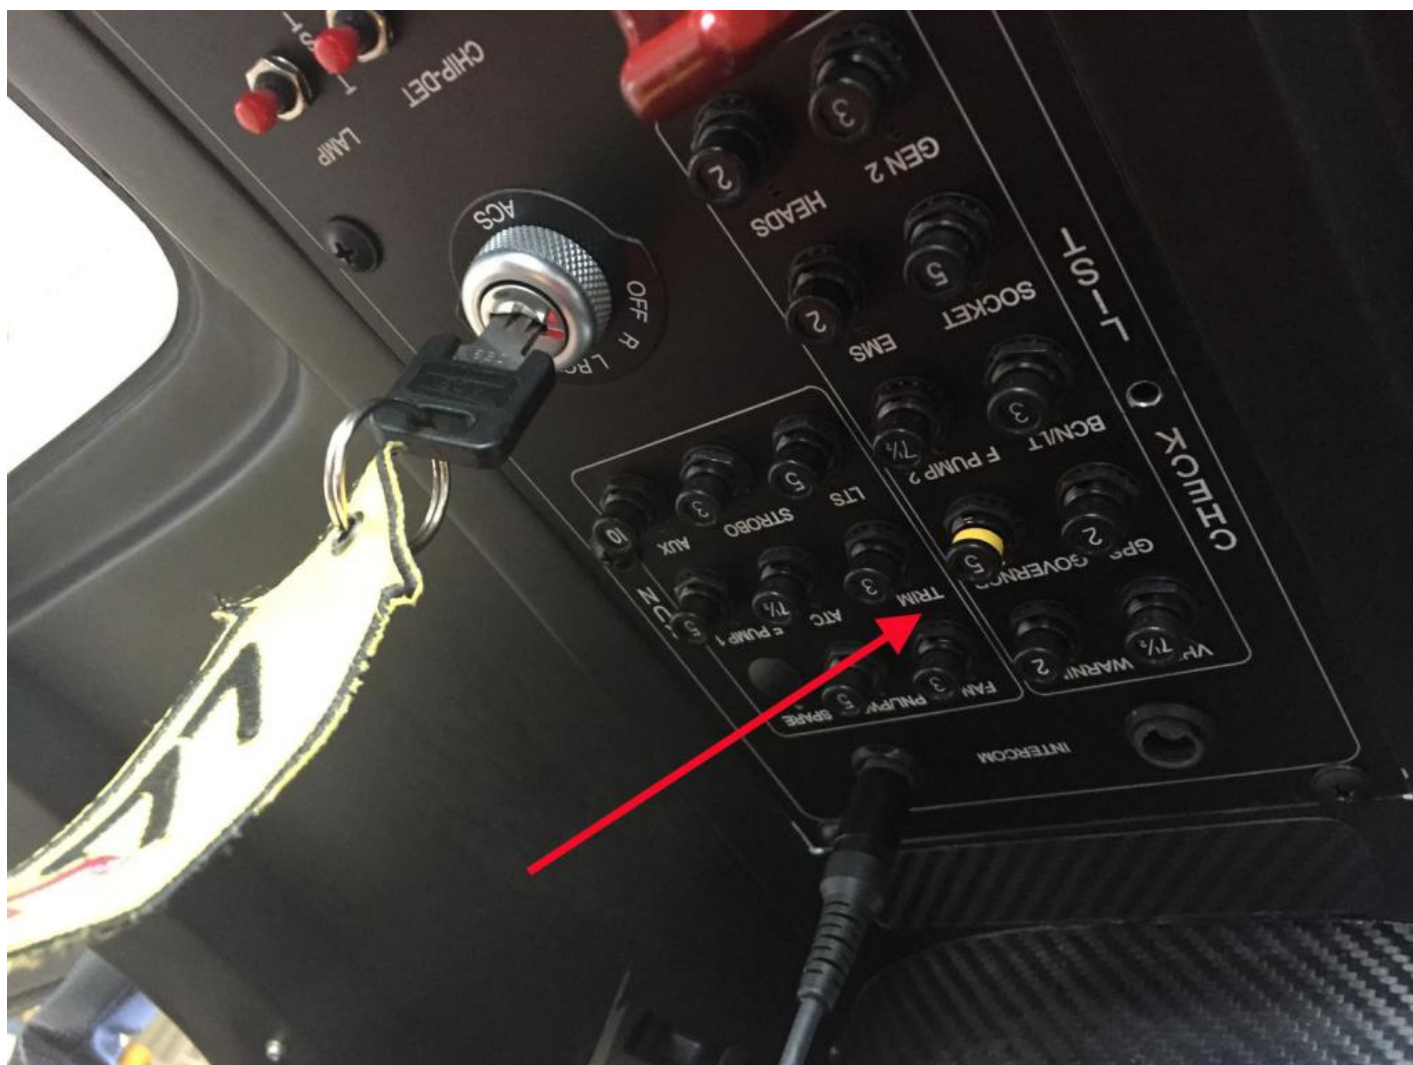
CH77-SWITCH BREAKER WITH YELLOW RING

put a yellow ring around switch breaker indicate in picture to recognize in case of flight problem and also to confirm the application of this service bulletin see picture 3) CH77 4) kompress

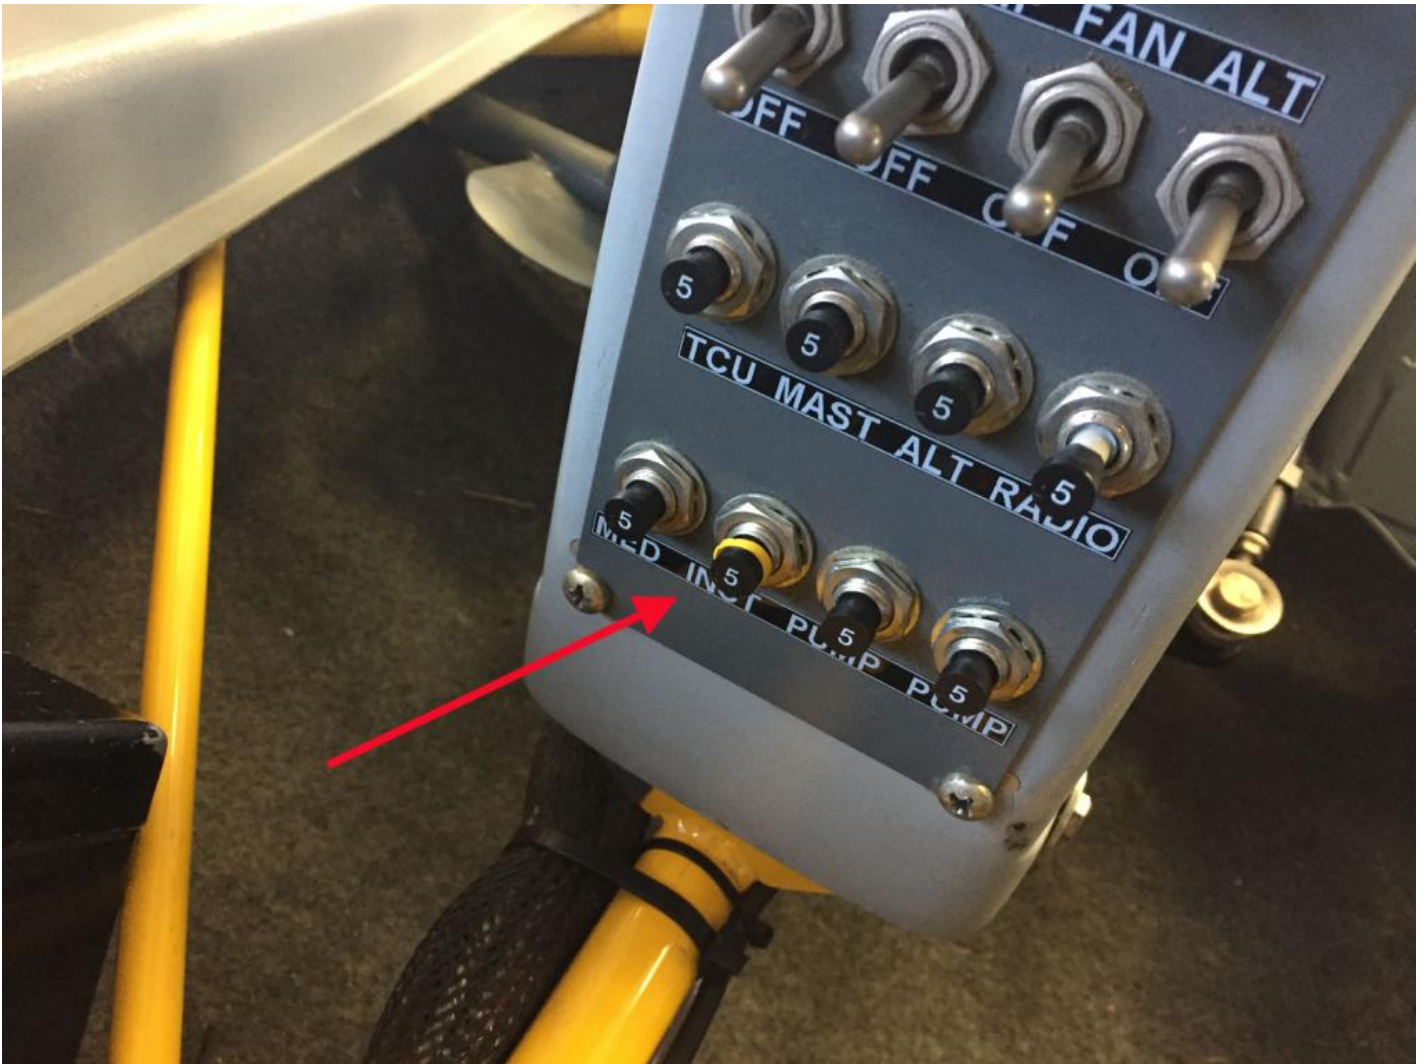
CH7-SWITCH BREAKER WITH YELLOW RING
