: # SB-R03

**AFFECTED PRODUCTS:** CH77 Ranabot

**SUBJECT:** CABIN CARBON SHEETS

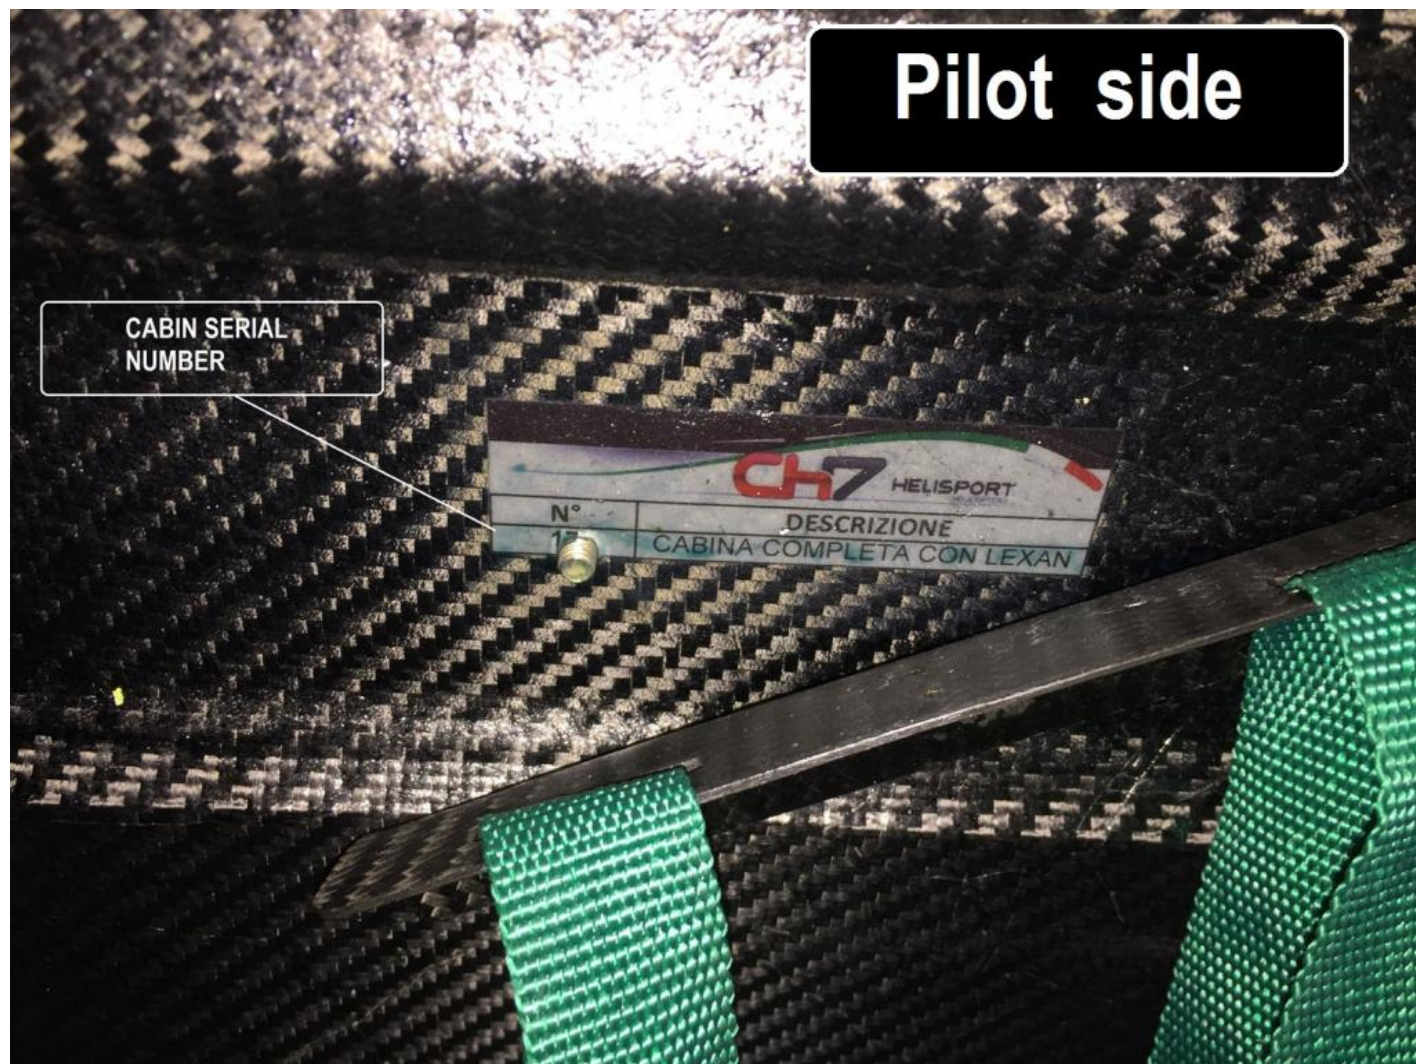
1) Remove four bolts AN4 belts ventral place pilot left side (1), the left side passenger seat (2) and right (3) and stop the collective support (4)

3) drill with 6.4mm carbon sheets into appropriate position

5) applying a layer of glue on the entire surface of the carbon sheet, can be inserted bolts used to center nad aslo to fix, fixed in place with adhesive tape repeat the 'operation to points (1) (2) (3) (4)
